# Evaluation of Land Use Types and Physical Soil and Water Conservation Structures in Wyebela Watershed, Northwest Ethiopia

Simeneh Demissie Walie<sup>1</sup>, Getachew Fisseha<sup>2</sup>

Department of Soil resources and watershed management, Gambella University, Ethiopia

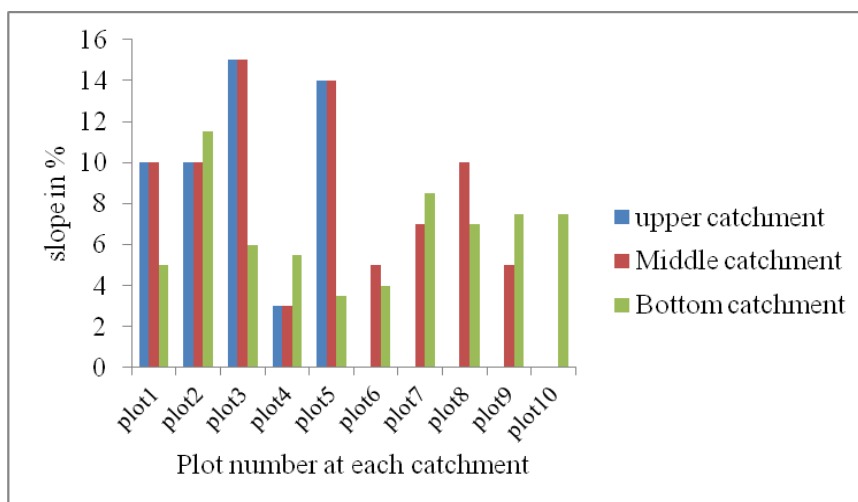
Fig.1 Average slope percentage at the three parts of catchment

Soil depth and slope percentage at each plot showed significant variability. The variability of soil depth was generally higher than slope percentage variability. This variability has implications for the necessity of planning SWC activities for each plot. It was also possible to see the correlation between these two parameters. They had a negative relationship ( $r = -0.558^{**}$ ). This means that the soil depth decreases with an increase in the slope percentage. However, the relationship was significant both at 0.01 and 0.05 levels. The reason for the negative relationship was that higher slope areas were plowed without proper SWC practices, which resulted in higher erosion and reduced soil depth.

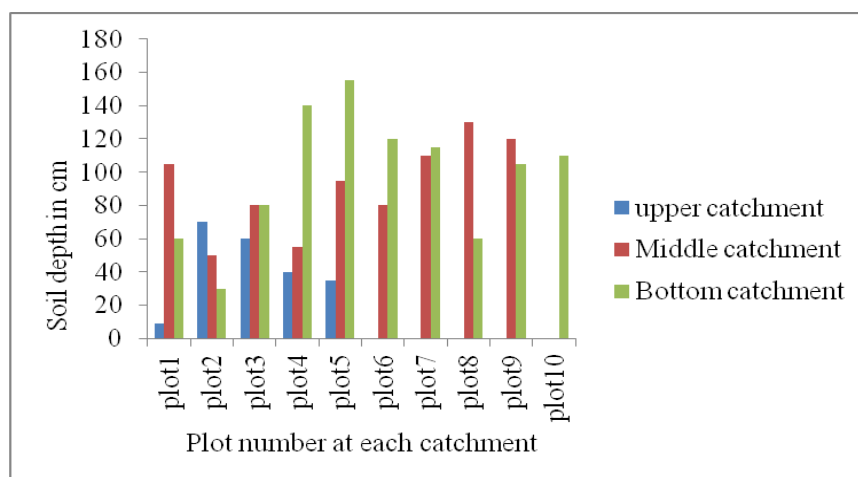
Fig. 2 Soil depth at three transect line plot sites

Although the average soil depth of the area was as deep as 88 cm, but there were farm plots in which soil depth was as low as 10 cm (Fig. 2). However, the TOC classification scheme prohibits tillage of land with a soil depth less than 20 cm. In such farm fields, the soil depth cannot accommodate local plowing activity. This shallow depth of soil, accompanied by poor water infiltration capacity, has aggravated the rate of erosion. In the Wyebla watershed, plots that have less than 20 cm soil depth were kept under area closures and used for plantation purposes by constructing water harvesting structures (Fig. 4).

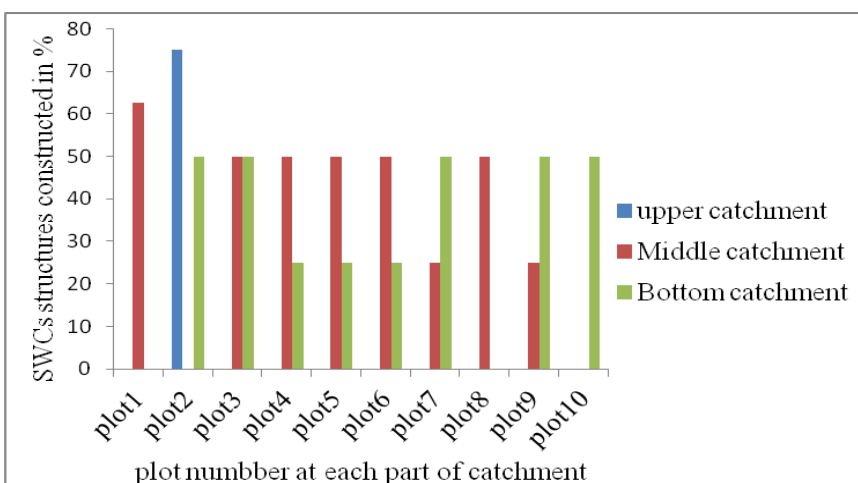
Fig. 3 Percentage of SWCs structures constructed in each plot

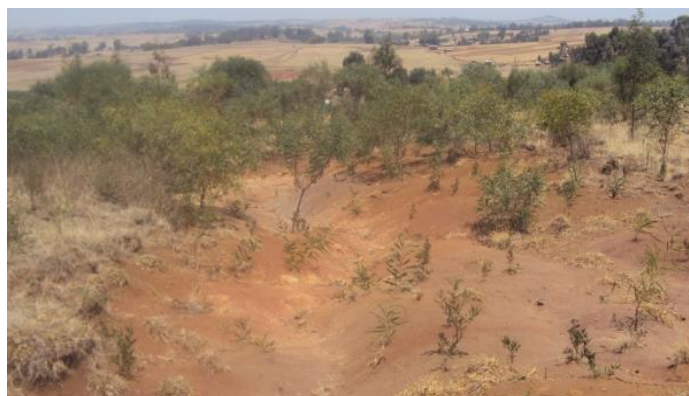
Fig. 4 Degraded area under area closure
